# Drainage of miniature dry dock with Heidra hydraulic submersible pumps

Ingleside, TX

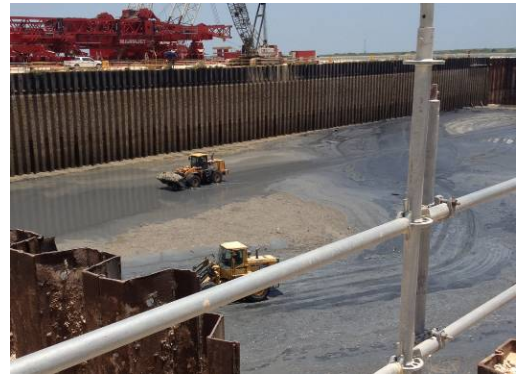
Silt and other contaminants are being moved toward sump area for removal and disposal.

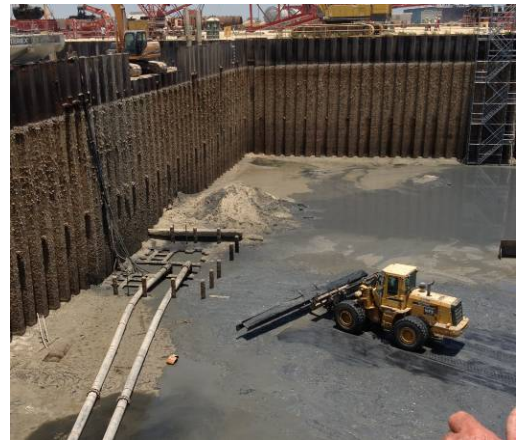
Customer is pushing silt from bottom of the structure to the sump area. Pumps will remove excess water and silt to retention pond for disposal.

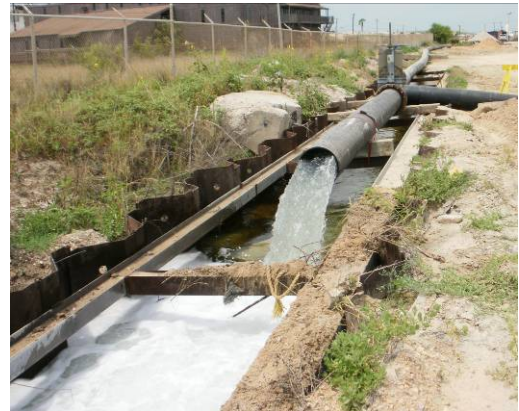
Tee to divert silt-free water back to bay or water containing silt to the retention pond.
