# Non-Genuine UV Lamp Replacement Compromises Performance and Water Treatment Reliability

**COUNTRY:** Middle East  
**APPLICATION:** Wastewater, Water Treatment  
**SOLUTION:** Wedeco Ecoray® lamps  
**YEAR:** 2017

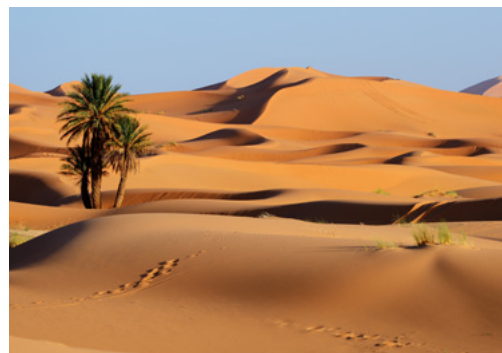
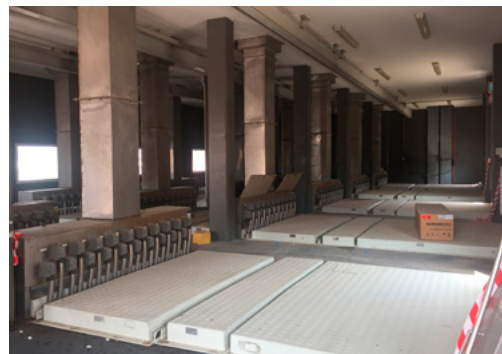
Wastewater treatment site with Wedeco UV disinfection system proves original Ecoray lamps superior performance versus 3rd party non-genuine lamps.

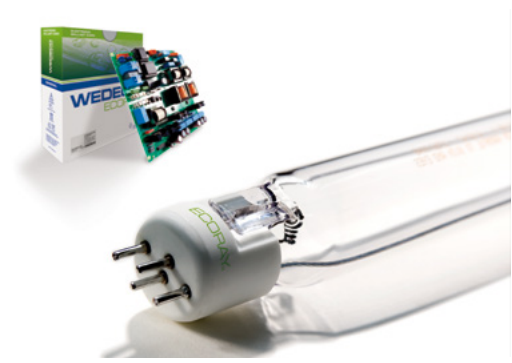
Ecoray high output low-pressure lamps and ballast cards have low power consumption. The lamps emit high UVC even in dimmed mode, and have a guaranteed lamp life.
