Scottish Water, United Kingdom

INSPECTION INSIGHTS ENABLE UTILITY TO EXTEND THE LIFE OF A CRITICAL RAW WATER MAIN
REDUCING COSTS, RISK, AND CARBON EMISSIONS

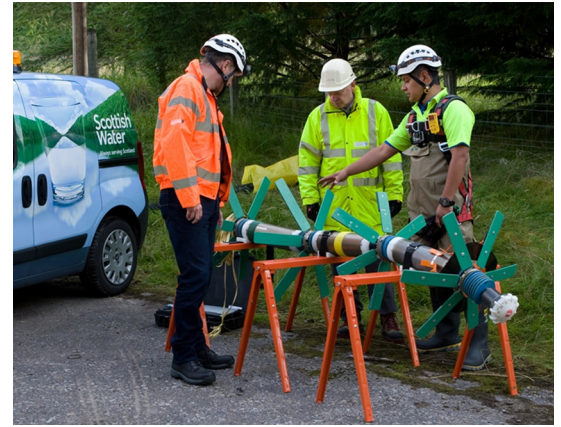
Preparing the PipeDiver platform to inspect the Newmore Raw Water Transmission Main

The team first inspected the main for leaks and gas pockets using Xylem's **Smartball® platform**. They later deployed the **PipeDiver® platform**, which uses electromagnetic technology to locate and quantify broken wire wraps in each pipe. For the best possible accuracy, the tool's sensors were calibrated using a spare pipe from the Newmore Raw Water Transmission Main.

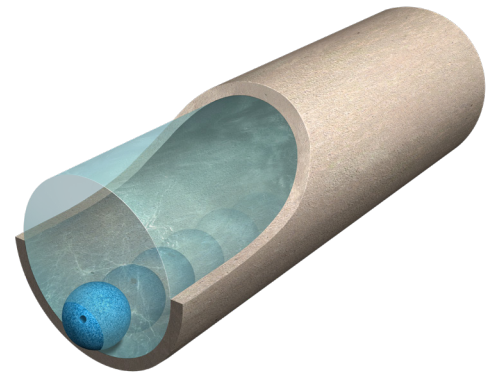
Xylem's SmartBall inline leak and air pocket detection platform

Overall, the pipeline is in serviceable condition. However, the inspections identified some areas of concern. The SmartBall platform identified five leaks of varying magnitude along an 800-meter (0.5 mi) section of the pipeline. Further investigations revealed that these leaks occurred at pipe fittings and were not caused by joint issues or barrel defects. The PipeDiver platform inspected 3,382 pipes and identified 12 sections with broken wire wraps. One area of concern was a pipe with more than 25 broken wire wraps that was located near one of the large leaks detected during the SmartBall survey.
