# Acquedotto Campano, Italy

ITALIAN UTILITY IMPROVES SYSTEM RELIABILITY AND SAVES WATER, MONEY AND ENERGY BY LOCATING WATER LOSS ON A SUBMARINE PIPELINE

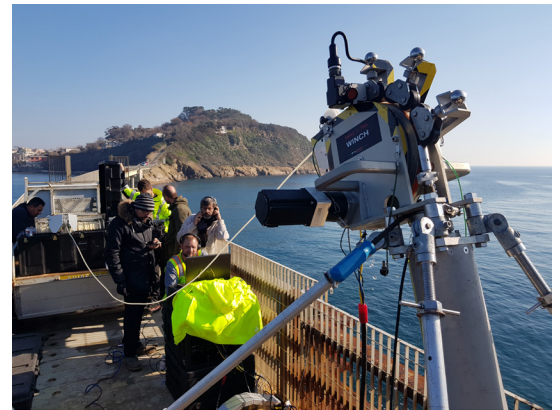
Inspecting the pipelines between Procida and Ischia, Italy with Xylem's Sahara platform.

The Sahara platform located a burst on one of the underwater pipelines between Procida and Ischia. Ena Sud quickly deployed divers to fix the leak. With this repair, Acquedotto Campano reduced non-revenue water loss by 50 liters per second – enough to provide a daily supply of water for a third of Ischia's residents. By locating and repairing the leak, the company can now provide reliable service during the busy summer tourism season, when the island's population increases more than threefold. Reducing water loss also lowers Acquedotto Campano's energy demand and benefits their bottom line.
