Xylem Delivers Actionable Data Within a Tight Time Frame to Enhance the Safety and Resilience of a Nuclear Power Plant

DEWATERING AND PCCP INSPECTION PROVIDE COMPREHENSIVE INSIGHT INTO PIPELINE CONDITION

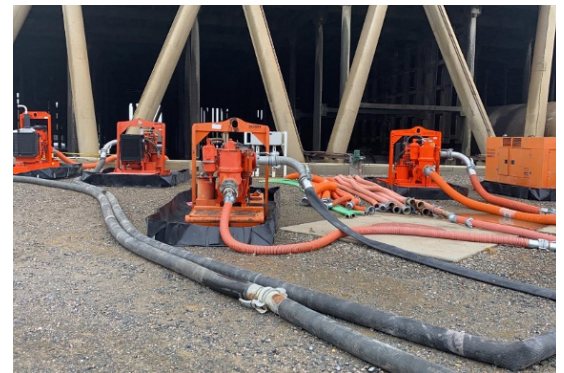
Twelve Godwin CD150MV pumps and 1,500 feet of suction hose were used to dewater the pipelines, to allow the condition assessment to take place. Xylem selected this pumping solution to handle the volume of water that needed to be removed in the short time frame available.

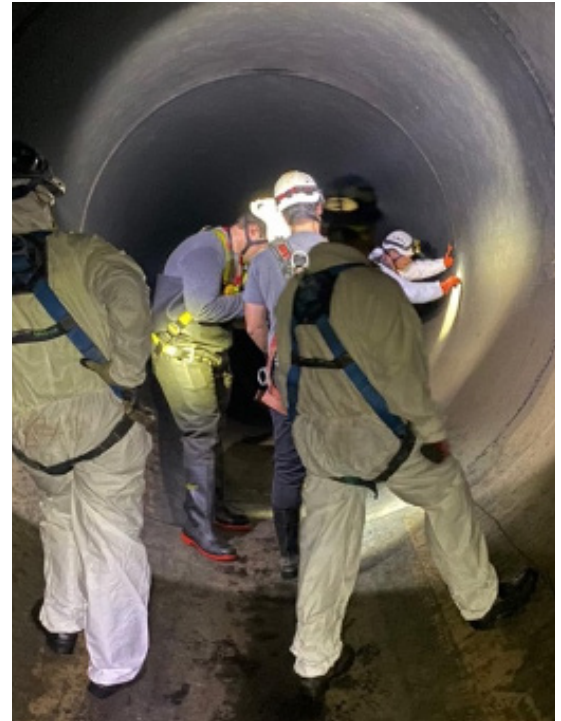
The Xylem team is pictured performing a visual and sounding inspection of the pipelines. This provides an additional data set to compare with information collected during an electromagnetic examination, and increases confidence in the location and presence of wire breaks and significant pipe wall deterioration.

Xylem conducted a complete dewatering and pipeline condition assessment that provided actionable data within a tight, agreed time frame. A number of the 204 pipes inspected were determined to have broken wire wraps. Out of those, ten pipes showed signs of visual distress, in addition to more significant prestressing wire damage. This information helped the customer to make knowledgeable decisions and prioritize repair work, which is planned for the next scheduled plant outage. Without the insight provided by the inspection, plant operators could have been faced with extensive pipeline replacement, difficult construction and extended downtime, all of which would cost several millions of dollars in repairs, as well as the potential for fines if the pipelines were to rupture. This inspection and the subsequent targeted repair work will enhance the plant's safety profile and support license renewal.

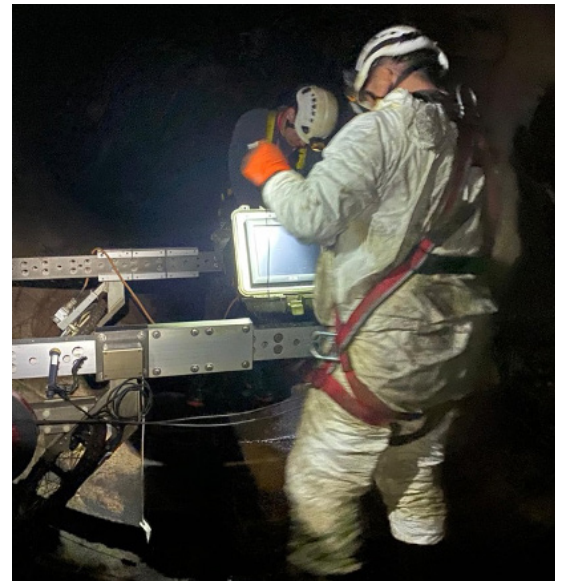
The Xylem team is seen here performing a manned PipeWalker electromagnetic inspection of the pipelines. This provides high resolution condition data about the pipe wall and prestressing wires.

Xylem's PipeWalker electromagnetic inspection tool provides a non-destructive method of evaluating the condition of the wire. It is capable of detecting broken prestressing wires and estimating the quantity and location of wire breaks for each pipe section. The Xylem team performed a manned electromagnetic inspection, combined with an internal inspection of the pipelines involving visual and sounding techniques.
