Safeguarding water supplies with SmartBall®

Town of The Blue Mountains tackles the hidden challenge of water loss with inline leak inspection services.

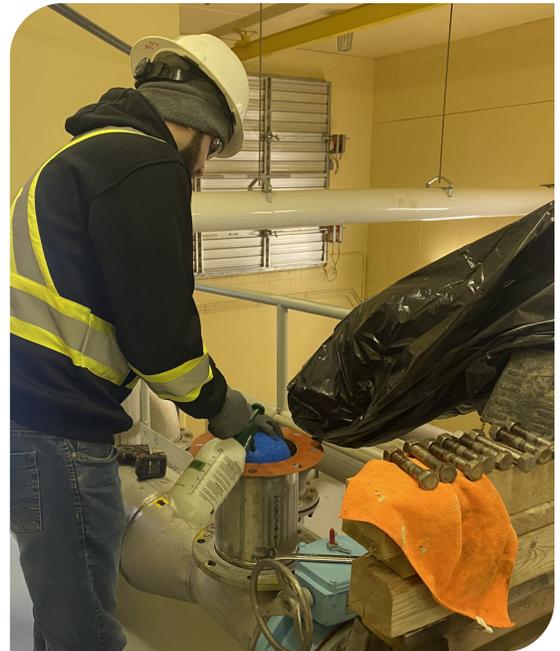
SmartBall insertion at the pump station

In just under seven hours, Xylem successfully inspected a 9.6-kilometer section of the trunk water main. Leveraging existing access points, the team inserted the tool into the pipeline at a pump station and extracted it from a hydrant.
