Creek Culvert Bypass Helps New York State Avoid a Major Road Closure

Unique solution provides access for critical repair work

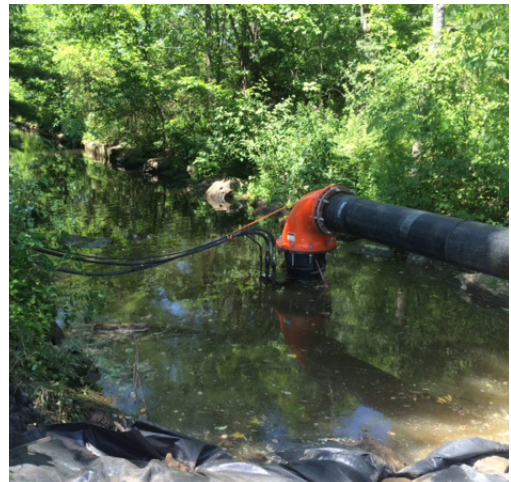
The DH Smith solution required a complete temporary bypass, with the piping passing through the culvert and rigging to hang the pipe off the side of the culvert.

The length of the bypass was approximately 200 feet, and the DH Smith team built rigging to hang the pipe along the inside wall of the culvert. Xylem flanged and connected 50-foot lengths of HDPE piping ahead of time at their rental dispatch and maintenance yard, so they could be easily lowered into the culvert, bolted together and slid into place in the rigging.

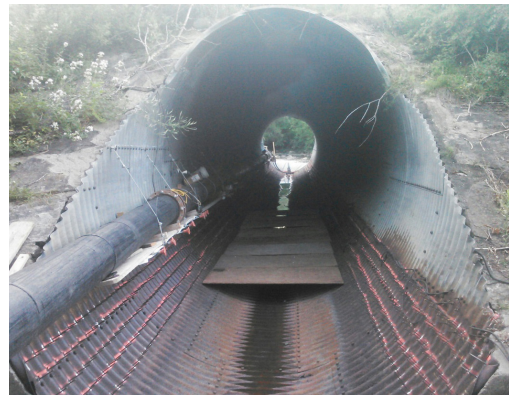
The DH Smith solution required a complete temporary bypass, with the piping passing through the culvert and rigging to hang the pipe off the side of the culvert.

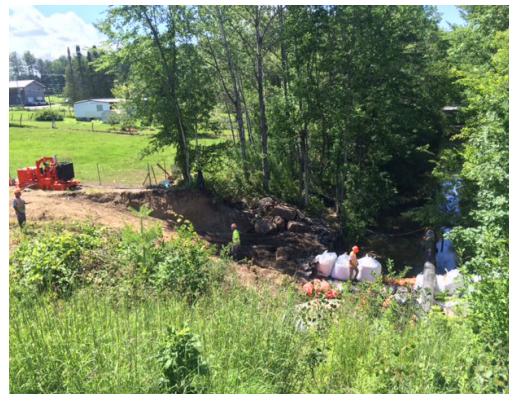
The Godwin power pack was situated 150 feet from the creek, addressing environmental concerns.
