# Power industry brings about a step change in water quality

DOUBLE WALLED PLATE HEAT EXCHANGERS OFFER A SUSTAINABLE SOLUTION TO INVASIVE MUSSELS IN THE GREAT LAKES REGION, PROTECTING THE LOCAL WATER SUPPLY FROM CROSS-CONTAMINATION CAUSED BY MUSSEL RELATED EQUIPMENT FAILURE WHILE USING 50% LESS COOLING WATER

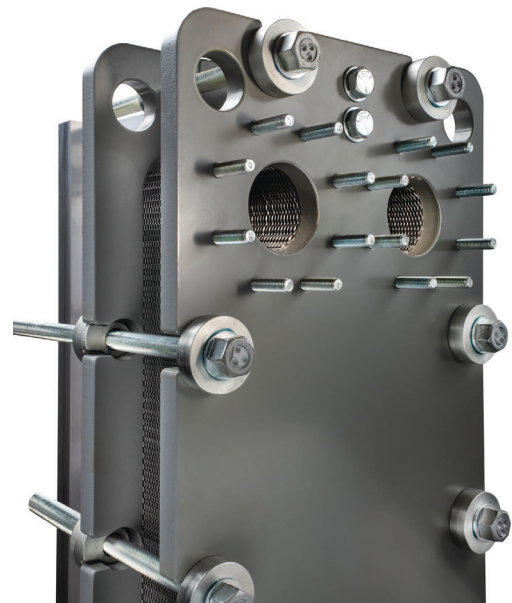
- Standard Xchange P14DW gasketed double wall plate and frame heat exchanger

The Standard Xchange gasketed double wall plate and frame heat exchanger provides double wall protection with the highest level of leak protection, safety, thermal efficiency and durability in a compact unit. No other technology is more compact, efficient or flexible. The double wall protection and dedicated leak ports provide quick and easy leak detection meaning leaks can be detected and addressed to avoid any cross-contamination of the river cooling water supply. This feature provides dependable protection of freshwater streams and water supplies for cooling of oils, glycols, and other fluids.

The 316 stainless-steel design of the P14DW offers superior corrosion resistance than materials such as brass and copper which are commonly used in heat exchangers.

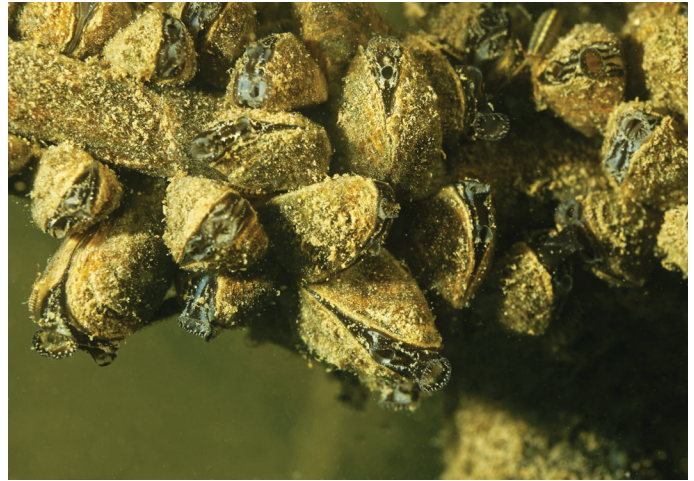
Zebra mussels pose a significant threat to the Great Lakes area, negatively impacting the aquatic biodiversity of the area.
